**MILLICOMA RIVER PARK and RECREATION
DISTRICT**

**Maintenance Handbook
for the
Community Center Building and its Grounds**

Arago Inspection
Property Inspection Report
Submitted to

March 24 and 25, 2009
Report Number: 090324

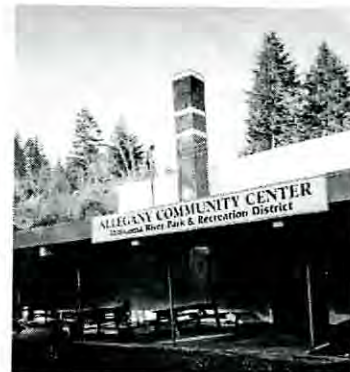
The brick chimney is 50 inches square and 45 feet high, from the bottom of the furnace room to the top. It has extensive cracks running vertically, and was considered unstable by the Arago Property Inspection Report of March 24-5, 2009. It was recommended that it be inspected by a brick mason. To that end, Duncan McTaggart was called to assess the chimney in September, 2009. He recommended that a stainless steel cap with a ten-inch flange be fabricated and placed on the top – that would stop rain from entering the chimney, and would stabilize the top rows of bricks, some of which are quite loose. He further recommended that a 10-inch steel band be placed at about five feet below the chimney cap, and another 10-inch steel band be placed about five feet below the first one.

The siding of the south gym wall meets the brick chimney. About 12 vertical feet of wood siding meets the brick chimney on the east and the west sides of the chimney. It had originally (1952) been caulked with butyl rubber or a similar caulking. Over the years, leaks occurred through the caulking and caused the studs and inside plywood to rot completely out. This has been fully repaired (as of February, 2010), and new aluminum flashing has been installed and sealed along both of the 16-foot vertical runs of the chimney and siding. This should prevent any recurrence of the leak.

There should be no maintenance required. The chimney should certainly be inspected carefully after any significant earthquake in the area. The roof membrane which attaches where the chimney comes through the roof (both at level 4 and level 1) needs to be always water-proof and repairs made immediately if needed. Serious leaking from the gymnasium roof down along the northeast and northwest sides of the chimney caused extensive damage in the past, but has been repaired with new flashing. Each time the building is painted, extreme care needs to be taken to insure that the flashing is re-installed in a leak-proof manner.

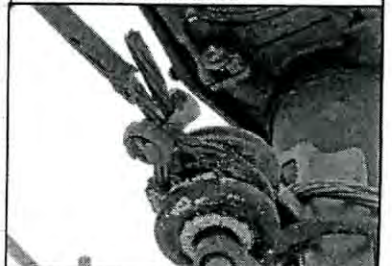
Bare wires on service drop conductors

77 **Electrical service:** The service drop conductors have missing insulation, with exposed
78 bare wiring. This is extremely dangerous and should be corrected immediately.

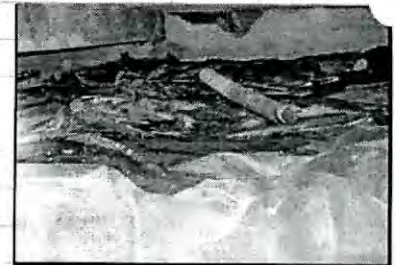
Standing water, NW under gym

51 **Substructure:** See page 6 for details. Much of the substructure is not accessible, due to
52 inadequate clearance under grade beams and piping. General crawl space clearance is
53 about 14 inches. The crawl space is divided by stem walls or beams into long bays. To gain
54 access, it is recommended to install access openings in the floor along both ends of the gym
55 and in the ends of the classroom building, to access each bay from either end.
56 In the NW corner of the gym there is standing water, dry rot in beams and joists, and wood
57 boring beetle damage in beams and joists. Repair of dry rot and a spray treatment for wood
58 boring beetles is recommended, along with improved exterior drainage and repairs
59 of leaks at the roof or exterior walls.

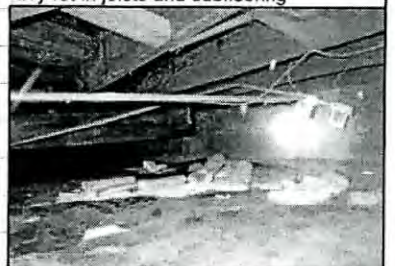
Friable asbestos fragments

86 **Furnace room:** There is friable asbestos around old heat pipes, some of which is damaged.

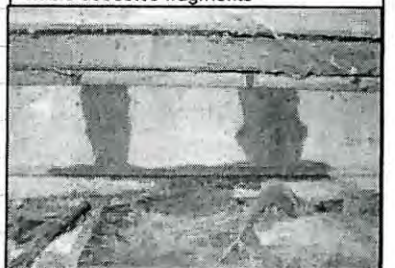
60 Under the classroom portion, ventilation is inadequate due to concrete stem walls
61 without vent openings. There is ongoing water intrusion along the west wall. Concrete
62 foundation blocks used as piers should be replaced with proper pier blocks.
63 Loose wiring should be properly supported. Wood waste should be removed. There is
64 evidence of rodents under the building. There is friable asbestos around old heat pipes, some
65 of which is damaged.
66

Water intrusion, west under gym

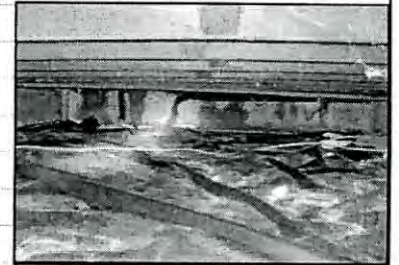
Water intrusion, W end, loose wiring.

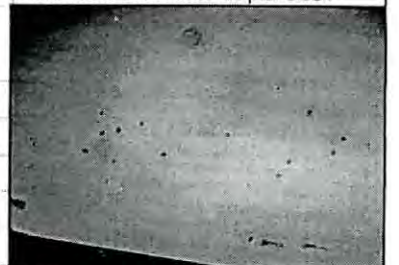
Wood boring beetle damage

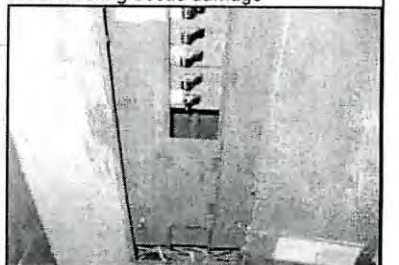
79 At the panel in the furnace room, open slots should be covered. In the
80 storage room above the stage there are older fuse boxes which should be upgraded.
81

Open slot in panel

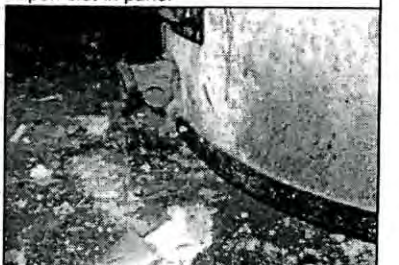
Water heater: The Bradford-White water heater is leaking. At the Reliance heater, the pressure relief valve piping should extend to 6 inches from the floor.

Leak at water heater
