Scottsburg Bridge

Primary Photographer(s): Nathan Holth
Bridge Documented: September 1, 2018

Key Facts

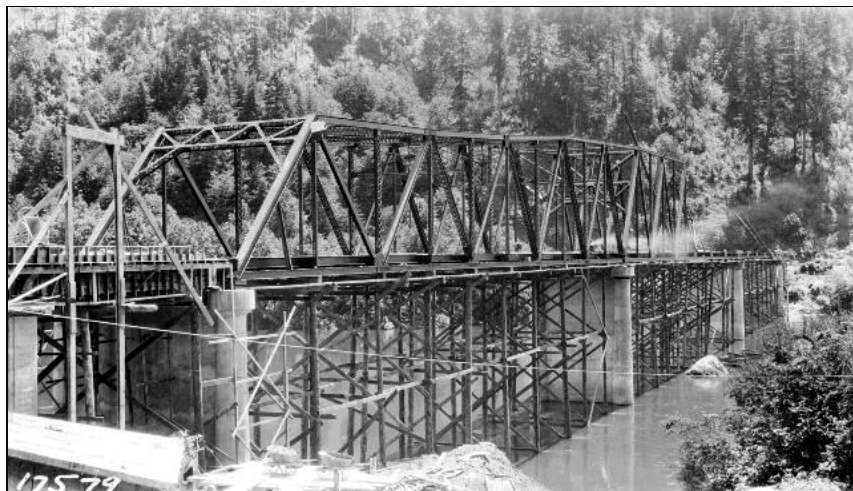
Above: Historical photo showing bridge construction.
